Property Condition Assessment

FINAL REPORT

Downtown YMCA
Shreveport, LA

October 12, 2018

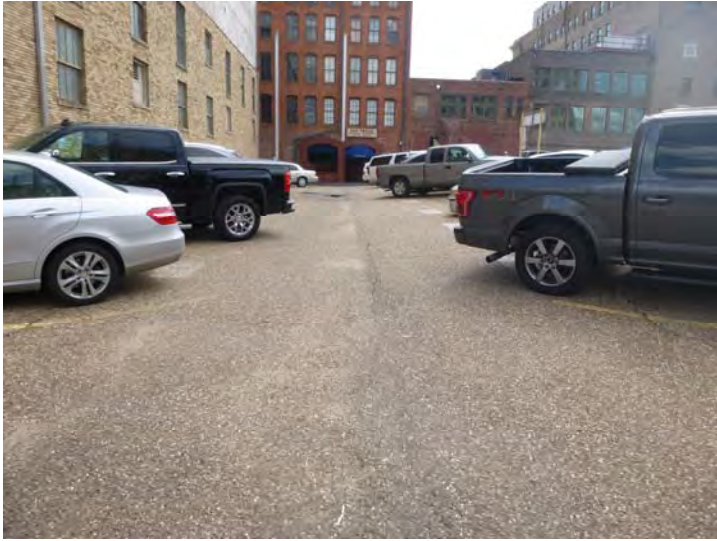
2. The asphalt pavement was observed to be in fair overall condition. Asphalt surfaces exhibit age related wear and vehicular fluid stains. Several areas of deterioration in the form of cracking and apparent base failures were noted, particularly at the back portion of the parking lot. Costs to scarify and resurface the asphalt surfaces are included in Years 6 and 7 of the plan. Interim costs for preventative maintenance repairs in the form of crack filling, sealcoating, and restriping are shown being handled as an operating expense.

View of the asphalt-paved parking area.

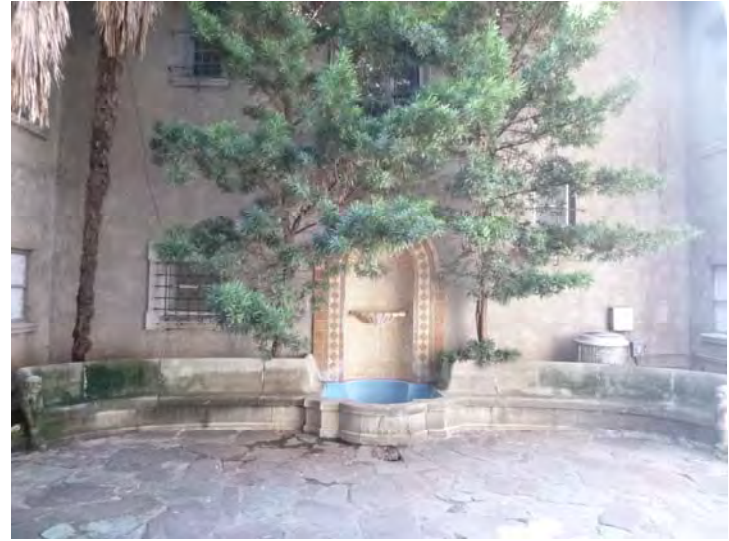
3. The central courtyard features stone elements, planting beds, and mature trees. Original architectural stone features exhibit discoloration and minor deterioration. The mature trees are oversized for the available space. Allowances to clean/repair stone and prune/remove trees are shown in Years 2 and 17 of the plan.

The courtyard.

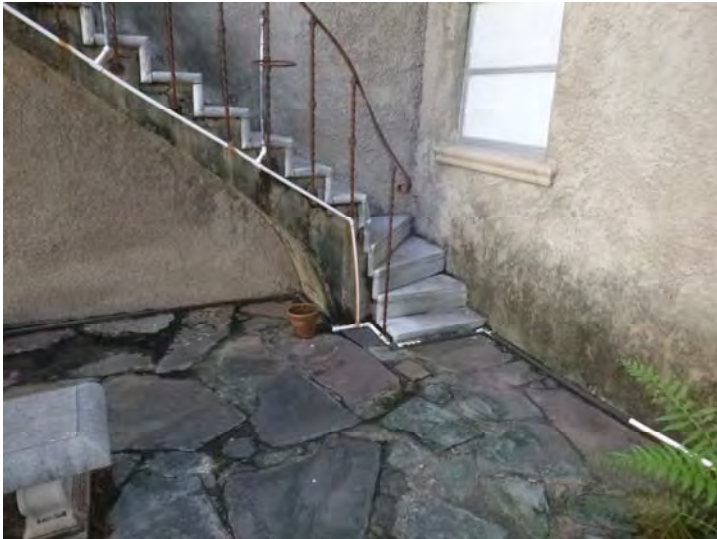
The stone stairs and metal railing at the courtyard exhibit rust and deterioration.

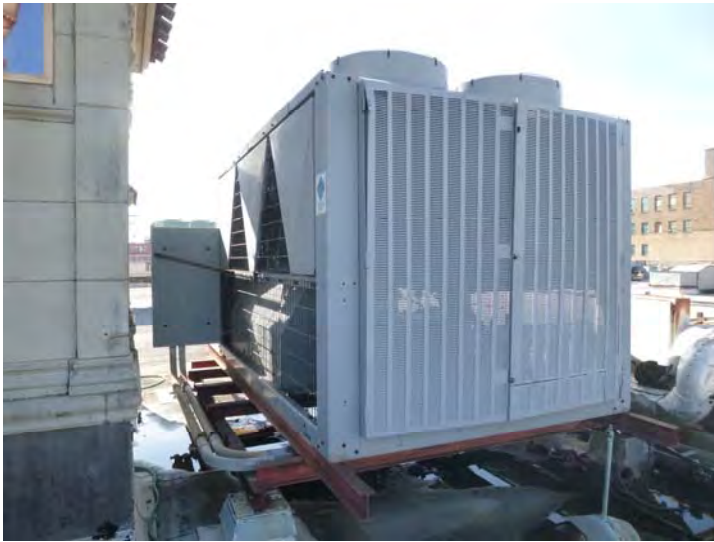
12. The building chiller is approximately seven years old and was purchased/installed used, in 2015. The reciprocating Carrier chiller has a rated cooling capacity of 90-tons and serves as the primary cooling system for the facility. Future replacement in Year 18.

The reciprocating Carrier chiller with a 90-ton cooling capacity.

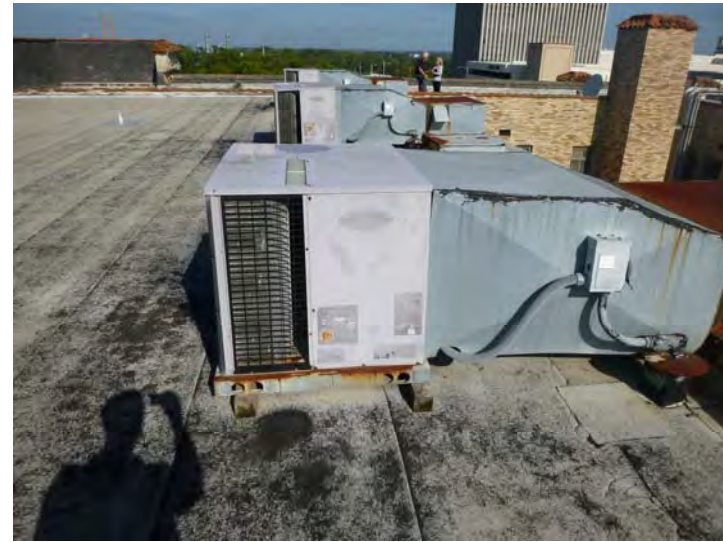
11. Space heating/cooling for the racquetball courts is provided by packaged roof top units and air conditioning condensers. The equipment is more than twenty-years old and is equipped with R22 refrigerant which does not comply with current standards. Costs to replace the rooftop units are included in Year 4. Air conditioning condensers are shown for replacement in Years 1 and 16 of the plan.

Three of the rooftop mounted packaged air conditioning units serving the racquetball courts.

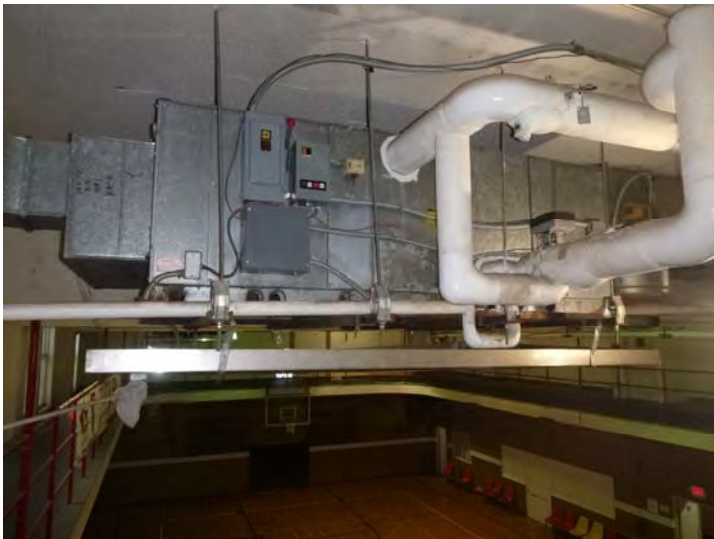
8. Air handling units equipped with heating and chilled water coils are located throughout the facility. Each unit varies in size depending on the conditioned space served. An estimate to replace AHU #9, 10, 11, 12, 14, 17 and two chiller air handlers was provided during the assessment. The replacement systems will reportedly include local thermostatic controls to allow for more energy efficient system control with programmable setback times. Costs (*based on current estimate*) to replace the remaining older air handlers are included in Year 3 of the plan.

Example of an older air handler (gymnasium) located throughout the facility.

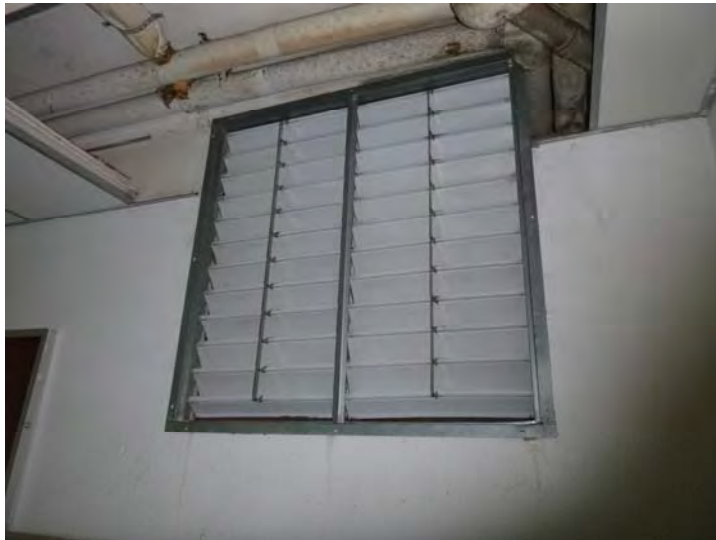
9. A powered exhauster serves the natatorium. The natatorium is not equipped with a dehumidification system at the present time. No problems/concerns were reported with regards to the natatorium's interior environment conditions, however evidence of corrosion was noted, particularly along the ventilation equipment openings. Costs to replace the powered exhausters serving the natatorium are also shown in Year 3. That said, OSI recommends consideration be given to the installation of a modern dehumidification system or heat recovery ventilator. A qualified design professional should be retained to determine the full scope and cost(s) of any ventilation or dehumidification improvements.

View of the louvered pool exhaust.

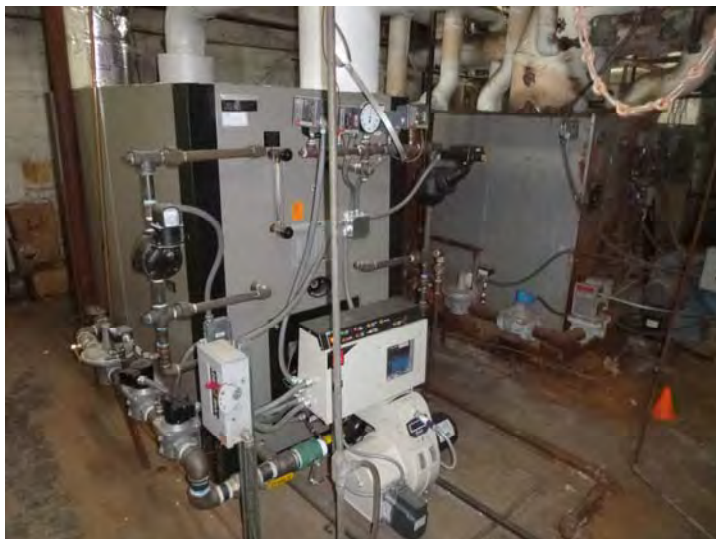
6. The steam heat and pool heating boiler was replaced in 2017, and no problems/concerns were reported at the time of the assessment. A second boiler is offline and has been abandon in place. It is assumed that this additional boiler may have been necessary when heating the top two residential floors of the building that are now vacant. Future replacement of the boiler is not anticipated within the plan's timeframe and periodic maintenance and repair costs are seen as an operating expense.

The recently install gas-fired steam boiler used to produce space heating and hot water (via heat exchanger) for the pool.

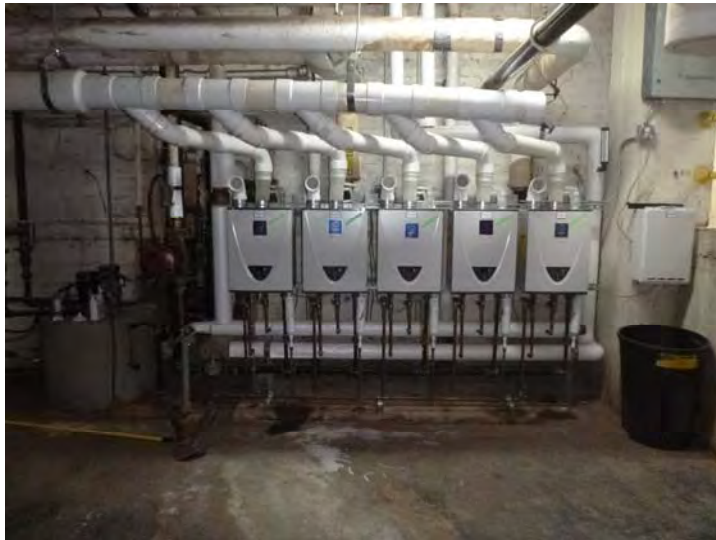
7. No problems/concerns were reported with regards to the five new high efficiency State Premier water heaters. Each water heater has a maximum rated input capacity of 199- MBH. Future costs to replace the water heaters are shown in Years 18 of the plan.

The new, gas-fired, high efficiency, condensing, instantaneous water heaters.

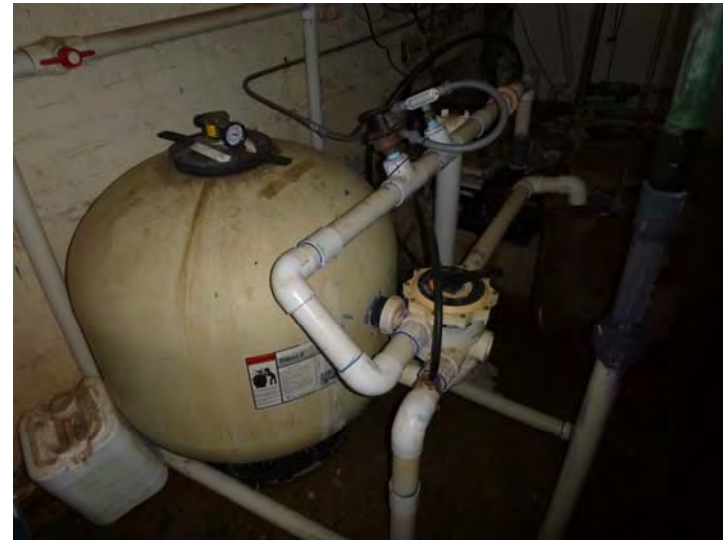
13. The filtration and treatment systems serving the indoor swimming pool were replaced in recent years (part of major renovation of pool). No problems/concerns were reported with regards to these systems. The sand filtration system, chlorine and acid feed systems, and base-mounted filter circulation pumps are shown for replacement in Year 10.

The pool filtration equipment and chlorinator.

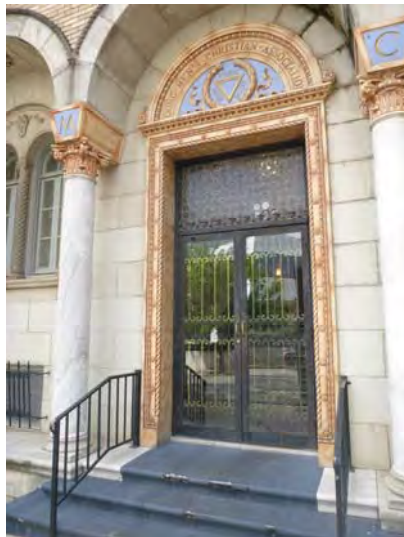
18. The iron-framed glass doors present at the main building entrance is believed to be original. The remaining double leaf aluminum-framed glass door at the Travis Street entrance is in good overall condition. These doors are shown being maintained as an operating concern during the plan's timeframe. Costs to replace the flush metal egress and service doors (including roof access) are shown in Year 4 of the plan.

The main entrance located on McNeil Street.

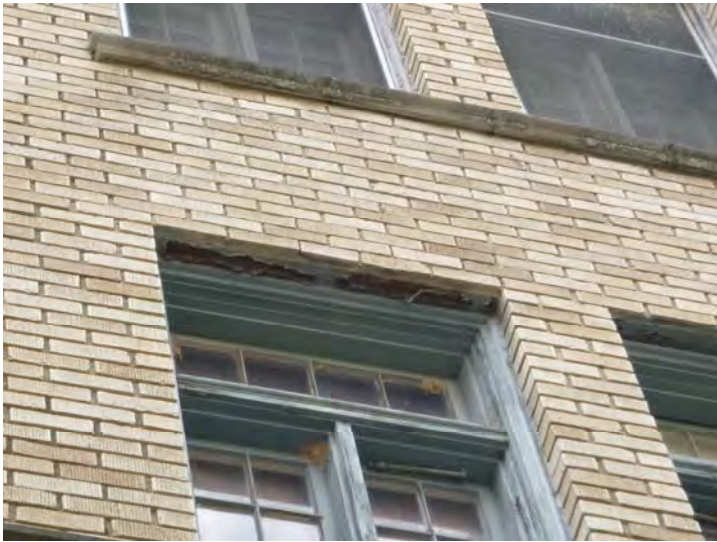
A close up of a window lintel exhibiting rusting and peeling paint. This condition is typical at all elevations.

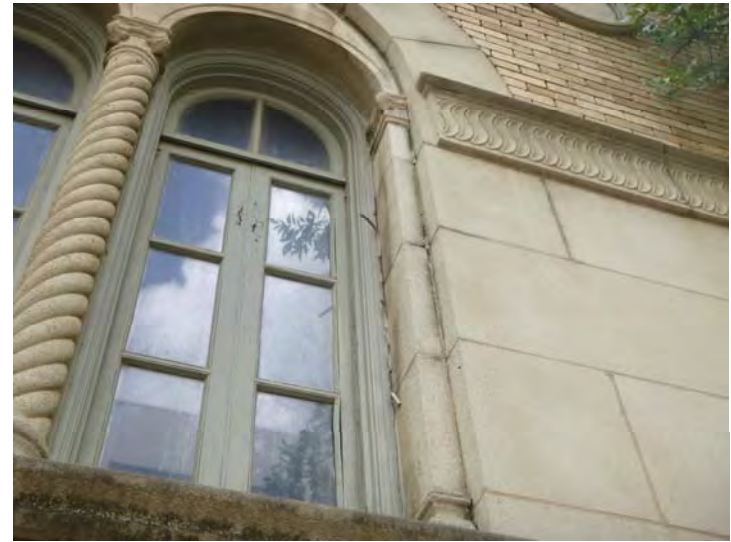
20. Overall, the exterior windows are in poor condition. The wood-framed, single-pane windows exhibit extensive deterioration at all elevation. Repairs, caulking, painting is understood to be included in the estimate for building envelope repairs described above. That said, full replacement of the windows is recommended. Replacements will need to comply with historic preservation standards. For discussion purposes costs are included in Year 10 for full

Close up of cracking/separating caulking and peeling paint at a first floor wood framed window.

replacement of windows serving the YMCA program areas with historic replicas (third and fourth floor windows are not included).

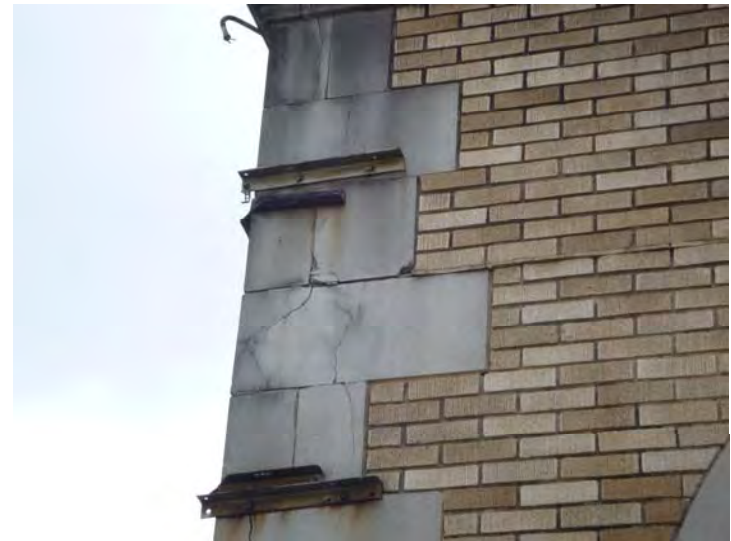
19. Overall, the brick masonry cladding exhibits extensive deterioration including overhead risk to pedestrians below. Areas of deterioration in the form of mortar loss, cracking, and apparent movement were observed. Pronounced cracking was also observed at corners and over many window lintels. In addition, wood elements exhibit extensive deterioration and visible caulking was noted to be cracking. At the time of the assessment a repair estimate prepared by a local contractor with experience in historic restoration was provided. These costs are included in Year 1. Allowances for similar work are included in Year 15 of the plan. The estimate is understood to include cleaning of all masonry; repair all mortar joints; repair/replacement of broken/cracking brick; re-caulking of all windows; repair/repainting of all windows, trim, louvers, vents, and metal railings; elastomeric coating at all stuccos surfaces; application of transparent water repellent at all masonry surfaces.

Close up of extensive cracking observed at the north corner.

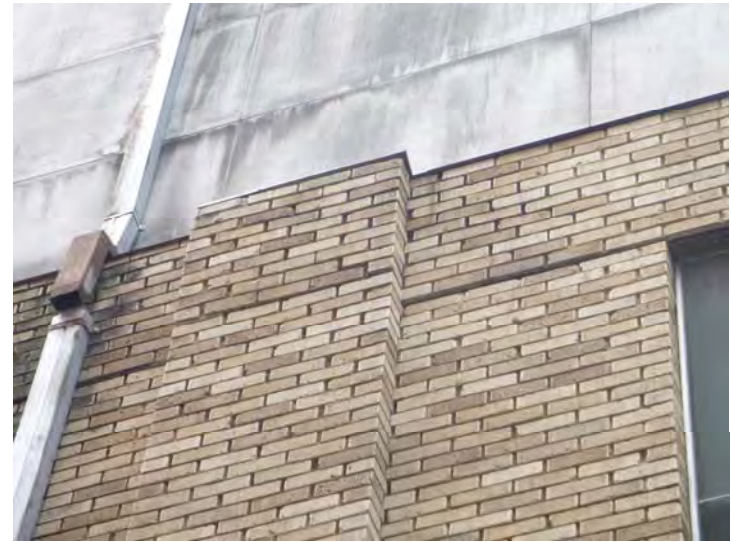
A pronounced area of mortar loss and apparent bowing/movement within the brickwork at the southeast elevation.

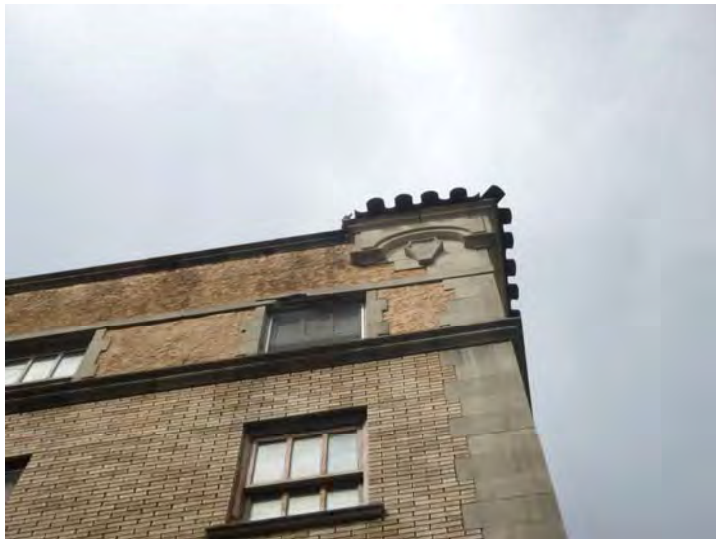
A cracked and flaking stone window lintel at the southeast elevation above a fourth floor window.

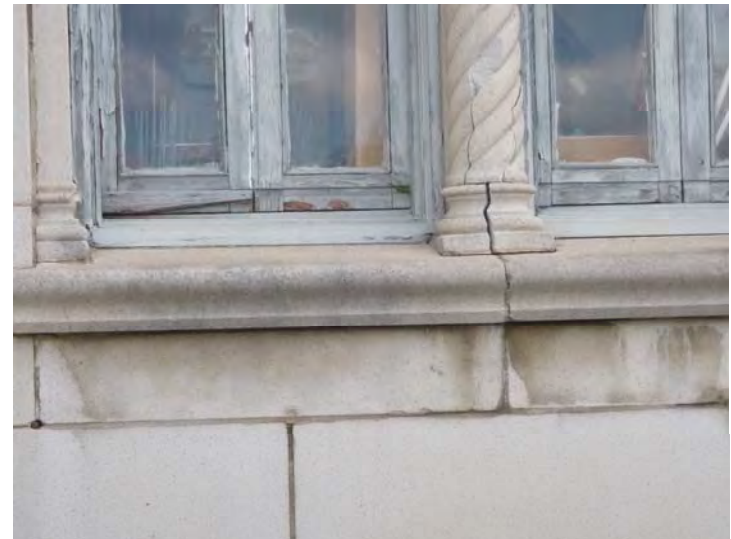
Example of cracking observed at a first floor window.

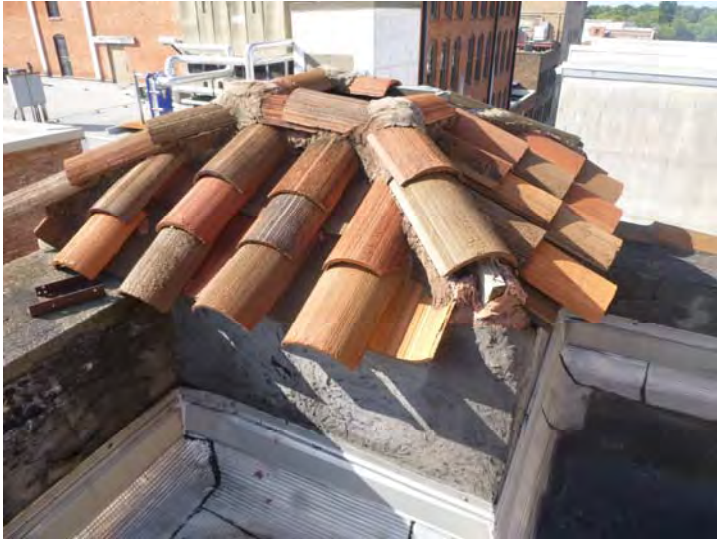
Missing or damage terracotta tiles are common.

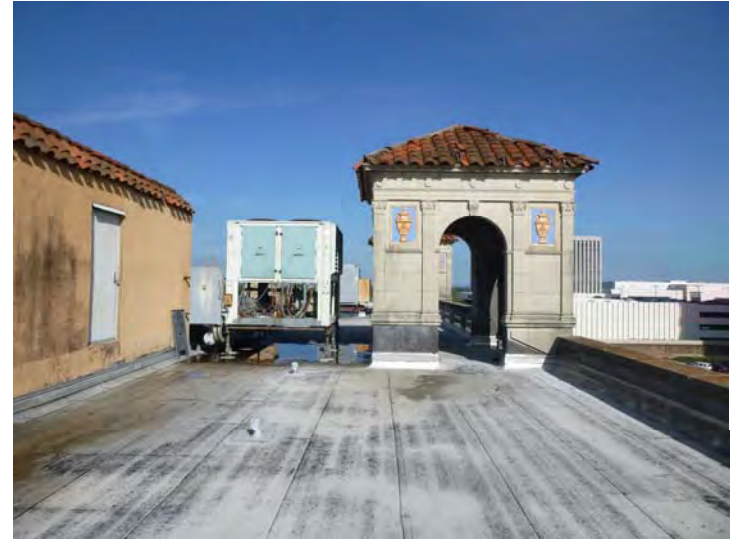
22. Overall, the single-ply rolled asphalt roofing system is in serviceable condition at the present time. However, the surfaces exhibits age related wear and deterioration. Incidences of past leaks and standing water were reported (particularly near the gymnasium roof) and the surface appears to be beyond its expected useful service life. Costs to replace the roof surface are shown in Year 4 of the plan. Based on observed conditions approximately 50% of the terracotta roof tiles are damaged, missing, or displaced. An allowances to repair the terracotta roof tiles are included in Year 1 of the plan.

View of the rolled asphalt roof surface.

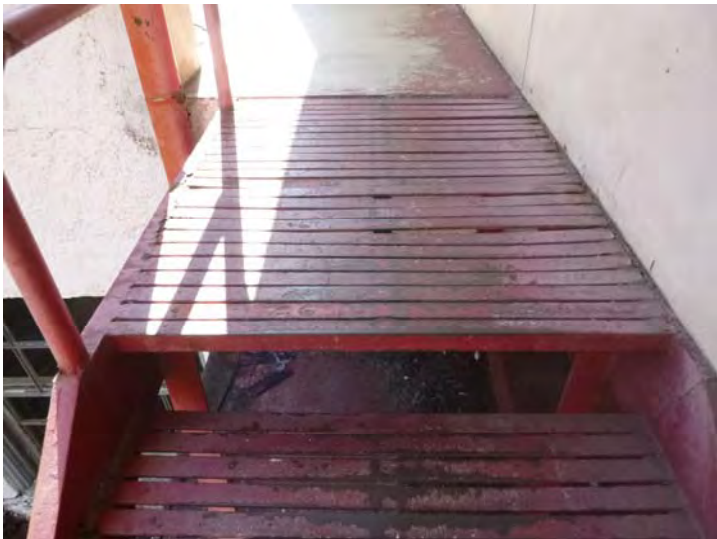
21. The building features exterior metal stairs used to access the racquetball court and a two story metal fire escape structure. Both were observed to be in fair to poor overall condition (including corroded railings). Costs for full replacement of both structures are included in Year 1 of the plan.

View of the exterior metal stair providing access to the racquetball court.

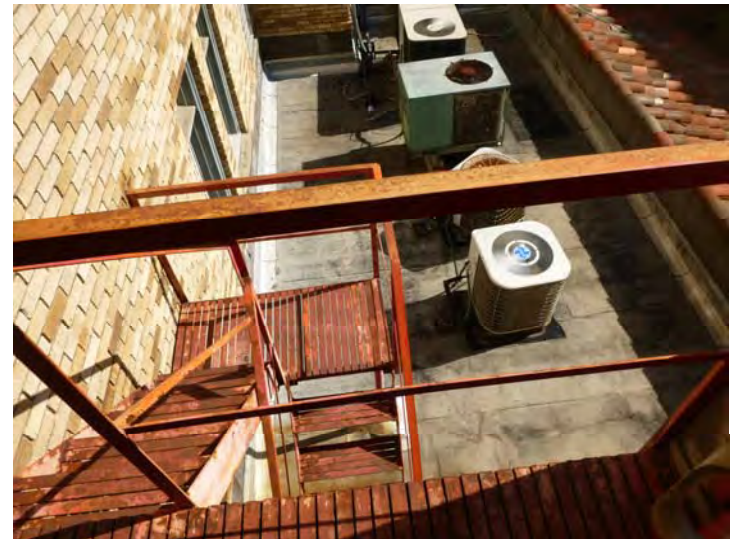
A similar metal fire escape structure, also observed to be in poor condition.

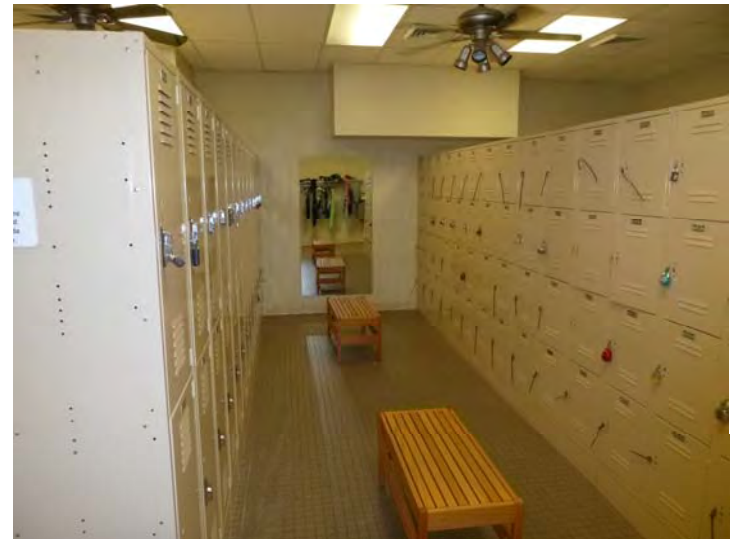
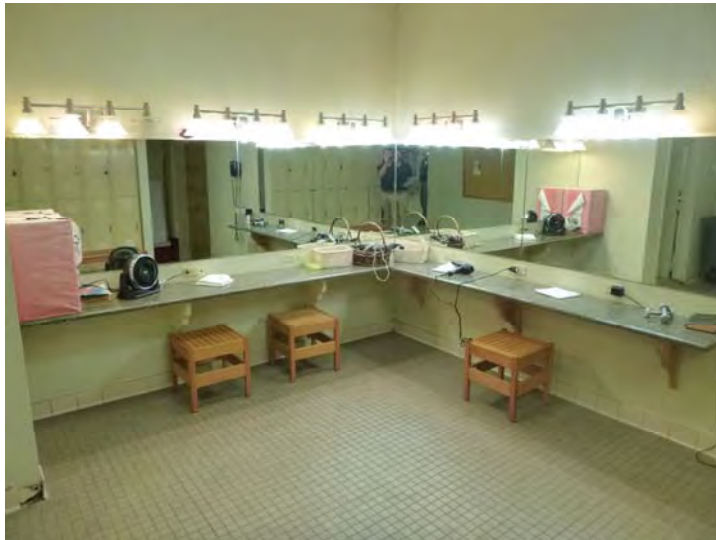
27. The women's locker room was created in 1985. A large portion of the suspended ceiling tile appears to be older, and select ceramic tile and carpet flooring exhibits wear. The metal lockers exhibit minor corrosion. The whirlpool is offline. Shower stalls are in serviceable condition. Based on observed conditions and discussion's held during the assessment, renovation of the women's locker room is seen as a major priority. Rather than providing costs for in-kind replacement a budget allowance for full renovation has been included here. Final renovation could vary from this estimate version as the scope of work expands to include specific product choices, energy efficient alternatives and upgraded materials/components or alteration to the existing building layout and use. Prior to carrying out major modification/improvement work, a qualified design professional should be retained to determine the full scope and cost(s) of the work.

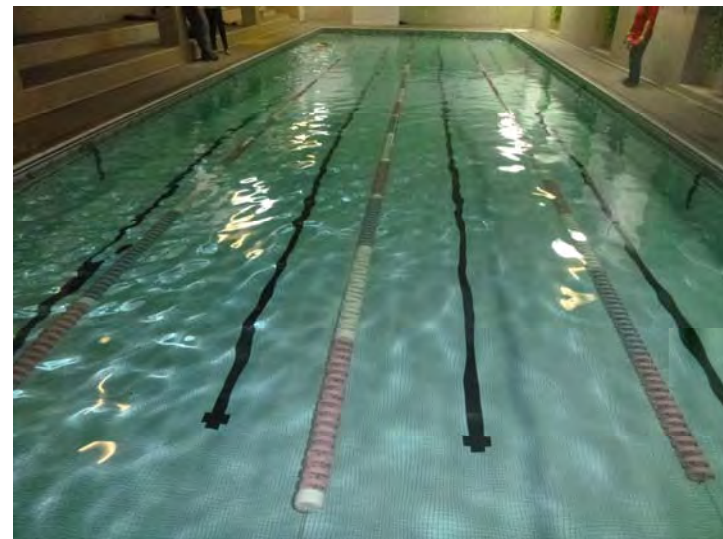
31. The natatorium was observed to be in serviceable condition at the present time. No leaking of the pool liner, drain, or gutter system was reported as these systems were recently upgraded. That said, the ceramic tile surfaces exhibit age replaced wear and discoloration. Costs to clean and repair the ceramic tile are included in Year 1.

View of the pool.

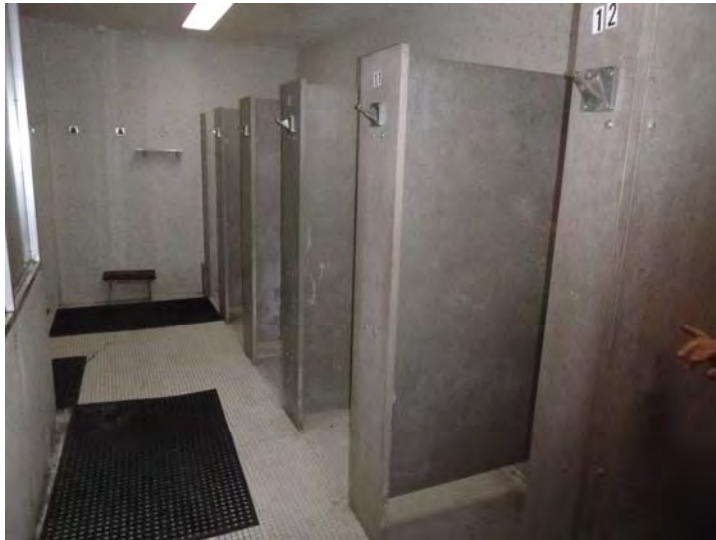
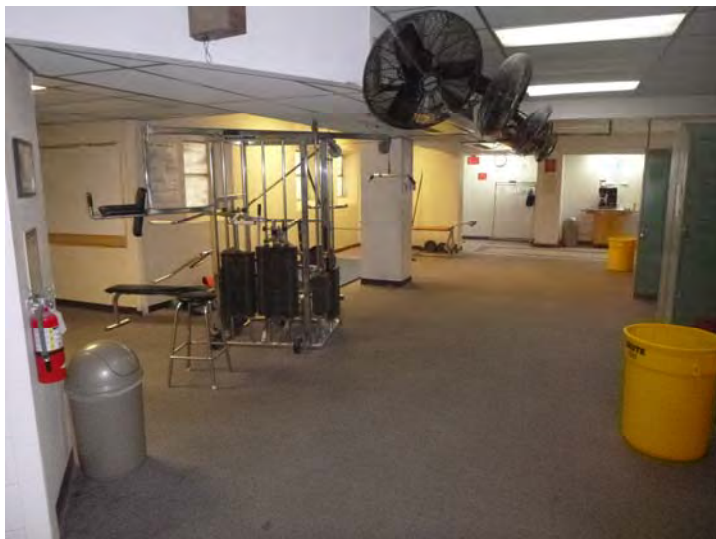
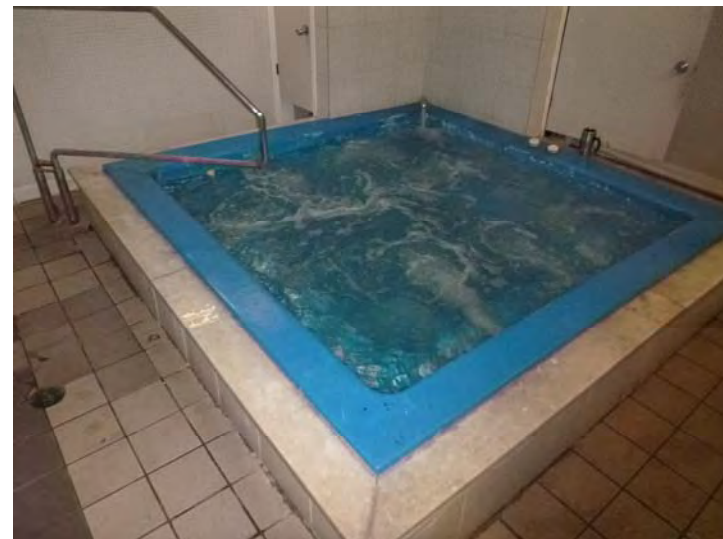
28. No major renovations or improvements to the men's locker room have been made since 1965. A large portion of the suspended ceiling tile appears to be older, and select ceramic tile and carpet flooring exhibits wear. Furthermore, the metal lockers exhibit corrosion at several locations. Shower stalls are in serviceable condition. The steam room is offline at the present time. The sauna and whirlpool were functioning as designed at the time of the assessment. Rather than providing costs for in-kind component replacement a budget allowances for full renovation has been included here. Final renovation could vary from this estimate as the scope of work expands to include specific product choices, energy efficient alternatives and upgraded materials/components or alteration to the existing building layout and use. Prior to carrying out major modification/improvement work, a qualified design professional should be retained to determine the full scope and cost(s) of the work.

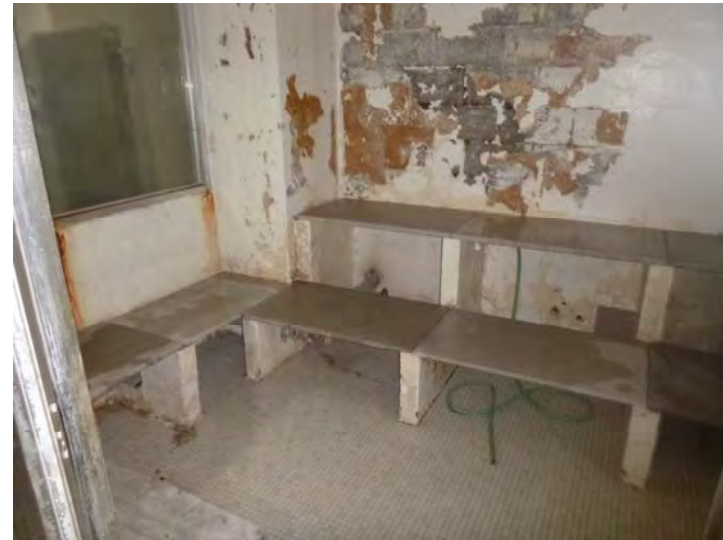
The steam room within the men's locker room is offline.
