Property Condition Assessment

FINAL REPORT

Downtown YMCA
Shreveport, LA

October 12, 2018

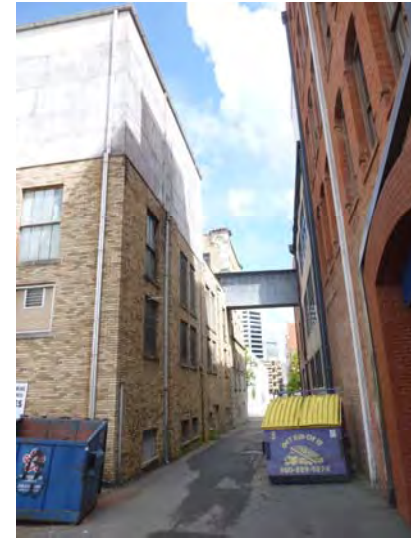
View of the asphalt-paved alleyway.

2. The asphalt pavement was observed to be in fair overall condition. Asphalt surfaces exhibit age related wear and vehicular fluid stains. Several areas of deterioration in the form of cracking and apparent base failures were noted, particularly at the back portion of the parking lot. Costs to scarify and resurface the asphalt surfaces are included in Years 6 and 7 of the plan. Interim costs for preventative maintenance repairs in the form of crack filling, sealcoating, and restriping are shown being handled as an operating expense.

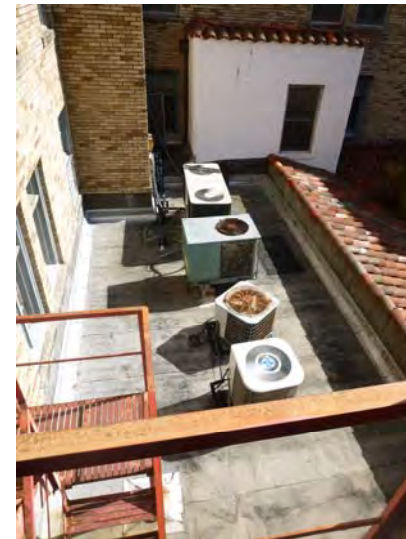
Smaller split system air conditioning condensers provide additional space cooling.

11. Space heating/cooling for the racquetball courts is provided by packaged roof top units and air conditioning condensers. The equipment is more than twenty-years old and is equipped with R22 refrigerant which does not comply with current standards. Costs to replace the rooftop units are included in Year 4. Air conditioning condensers are shown for replacement in Years 1 and 16 of the plan.

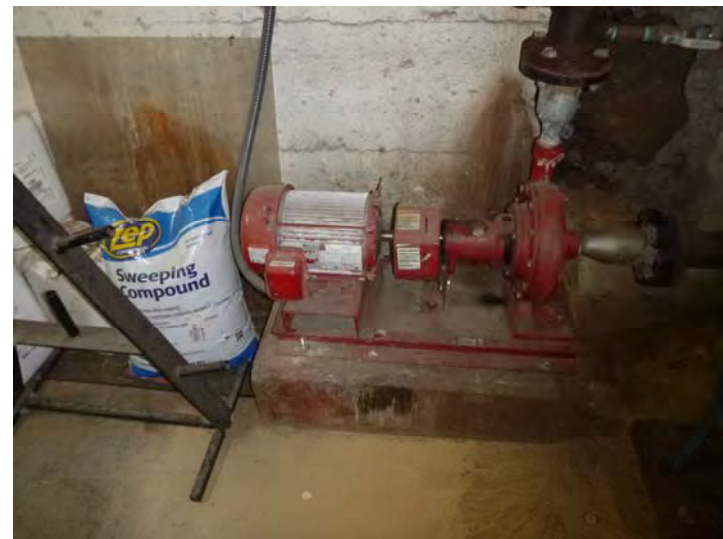
One of the 3-horsepower, base mounted circulator pumps.

13. The filtration and treatment systems serving the indoor swimming pool were replaced in recent years (part of major renovation of pool). No problems/concerns were reported with regards to these systems. The sand filtration system, chlorine and acid feed systems, and base-mounted filter circulation pumps are shown for replacement in Year 10.

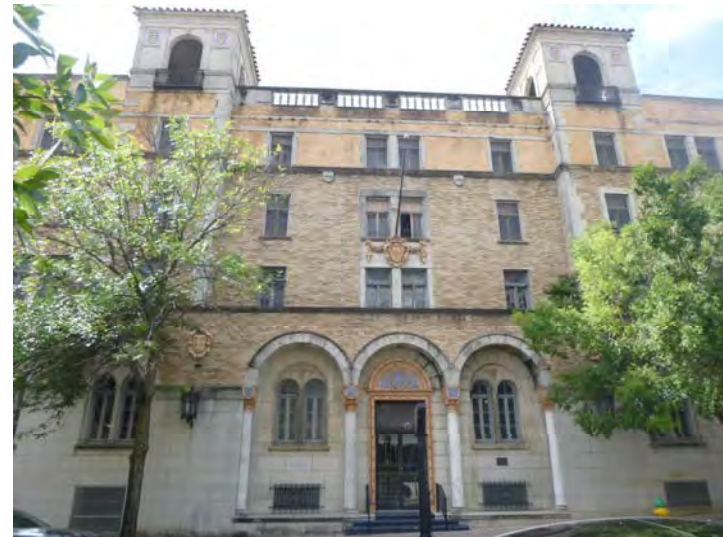
Typical building architecture as seen at the front elevation.

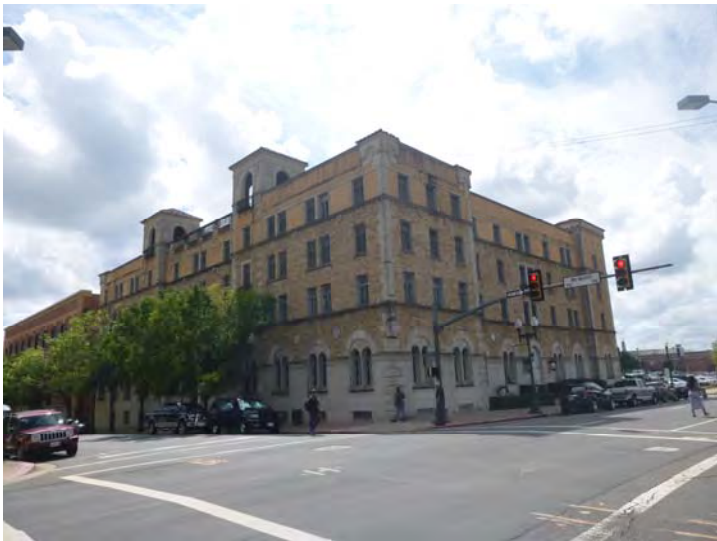
View of the McNeil Street and Travis Street Elevations.

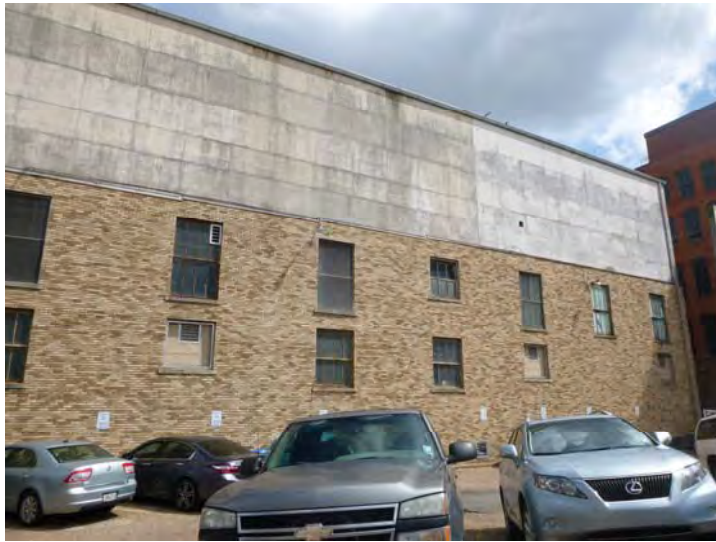
The rear elevation and racquetball addition.
